**Project:** 25\_5837\_10\_95  
**Site:** 7 Ridgway, Mount Ararat Road, TW10 6PR  
**Client:** Rob Lilley

| Document Title: | Tree Safety Survey |
| Project Title: | 7 Ridgway, Mount Ararat Road, TW10 6PR |

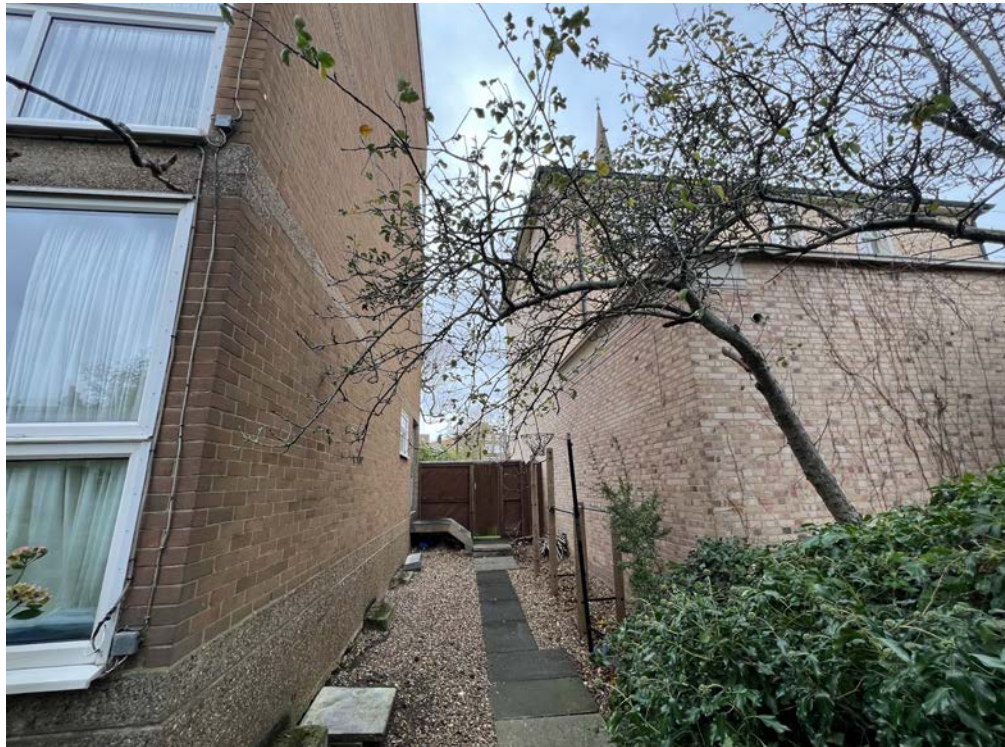
*Photographic plate showing T1 (right). (ROAVR, 2025)*

- Direct building conflicts:
  - T1 Malus has lower branches touching the southern gable; pruning to maintain at least 1 m clearance from the building is recommended.

| Tree ID | Species | Tree Height | Maturity | DBH | Life Expectancy | Phys Cond | Defects | Defect details | Management Recommendations | Estimated Duration of works | Priority |
|---|---|---|---|---|---|---|---|---|---|---|---|
| T1 | Malus (Apple) | 5 | EM | 170 | 10+ | Fair | Leaning North. Branches encroaching upon building. | Off site, lower part of the crown touching the southern gable. | Prune to clear building by specified distance.Prune clear of building by 1m | None | 12 months |

A further Malus (T1) and a Holly (T7) currently have branches in contact with adjacent buildings; light pruning to provide and maintain reliable clearance (1 m from the building for T1) is recommended within the next 12 months to reduce nuisance and fabric contact. The pollarded Limes (T11–T17, and T14 with a stem cavity) will need ongoing cyclical management and periodic inspection to control regrowth and check structural condition, particularly given their proximity to the underground car park.

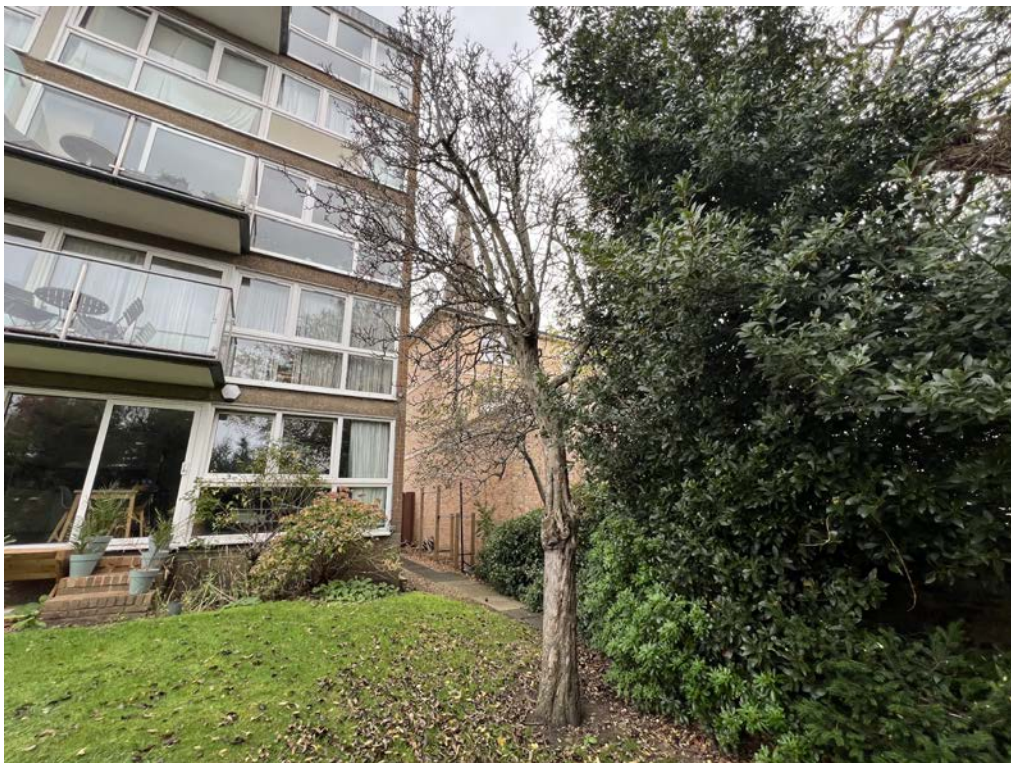
*Photographic plate showing T3 (centre). (ROAVR, 2025)*

- Tree health concerns:
  - T3 Malus is in decline, with poor form, low vitality and major bark wounding; this tree has a shorter remaining life (under 10 years) and will need closer monitoring and future removal and replacement planning.

| Tree ID | Species | Tree Height | Maturity | DBH | Life Expectancy | Phys Cond | Defects | Defect details | Management Recommendations | Estimated Duration of works | Priority |
|---|---|---|---|---|---|---|---|---|---|---|---|
| T3 | Malus (Apple) | 7 | EM | 250 | <10 | Declining | Poor shape & form. Low vitality. Declining. Major bark wounding on stem. Mechanical Damage. | None | None | None | None |

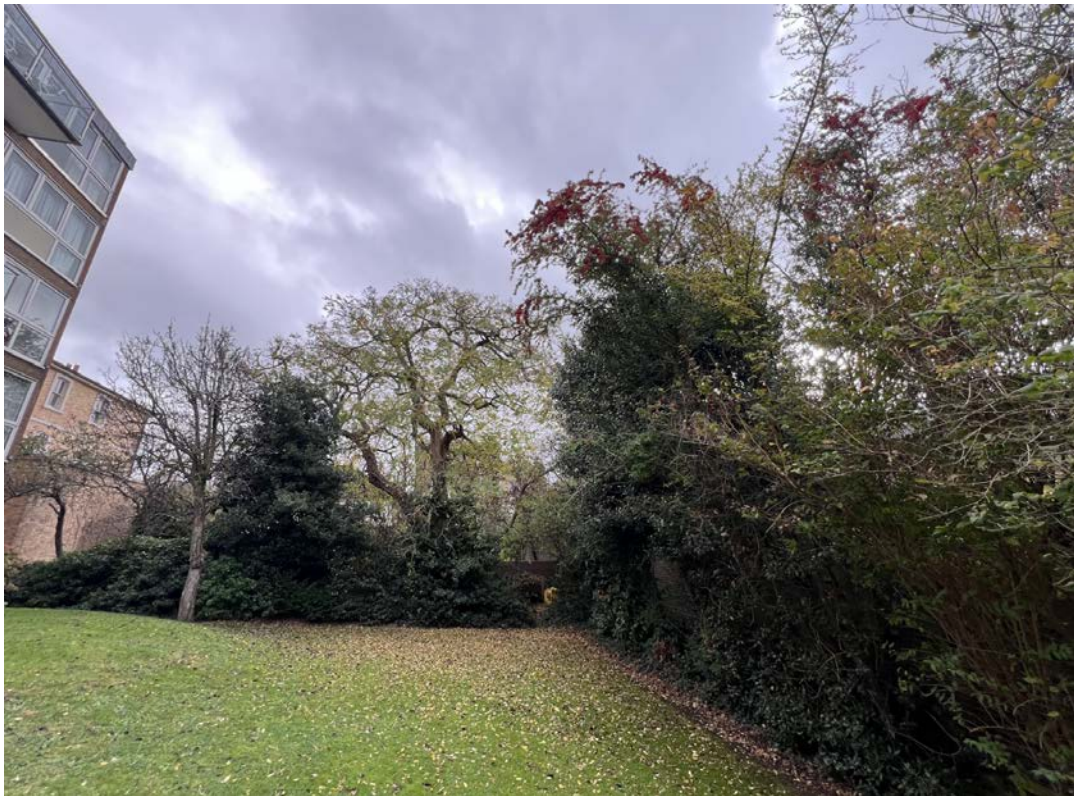
*Photographic plate showing T1 (left) to T8 (right). (ROAVR, 2025)*

- T7 Holly has crown contact with an off-site dwelling and will require periodic reduction on the west side.
- Surfacing and underground structures:
  - Horse Chestnut T19–T22 are already damaging adjacent block paving; further lifting and trip hazards are likely if no intervention is made.

| Tree ID | Species | Tree Height | Maturity | DBH | Life Expectancy | Phys Cond | Defects | Defect details | Management Recommendations | Estimated Duration of works | Priority |
|---|---|---|---|---|---|---|---|---|---|---|---|
| T7 | Ilex aquifolium (Holly) | 8 | EM | 200,220,250 | 10+ | Fair | Stem divides at ground level. Branches encroaching upon building. | Crown to the west touching off site dwelling. | None | None | None |

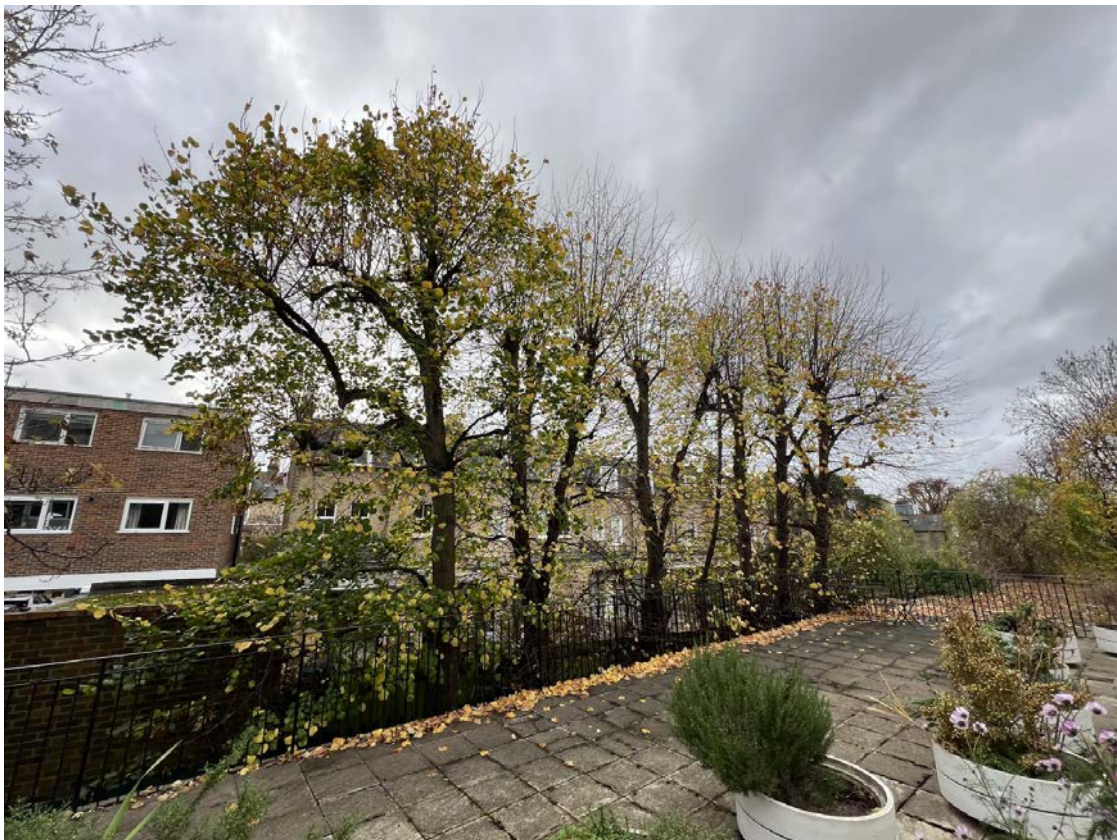
*Photographic plate showing T11 (left) to T17 (right). (ROAVR, 2025)*

- T14 Lime has a stem cavity which should be inspected at intervals to confirm residual wall thickness and structural safety, especially as it is managed as a pollard near the underground car park.

- Growth and maintenance demands:
  - The pollarded Limes (T11–T17) will continue to produce dense regrowth between cycles; without regular management this can increase sail area, shading and potential for limb failure.

| Tree ID | Species | Tree Height | Maturity | DBH | Life Expectancy | Phys Cond | Defects | Defect details | Management Recommendations | Estimated Duration of works | Priority |
|---|---|---|---|---|---|---|---|---|---|---|---|
| T14 | Tilia X europaea (Common Lime) | 12 | EM | 180 | 10+ | Fair | Pollard. Cavity on stem. | Between a boundary wall and the underground carpark. | None | None | None |

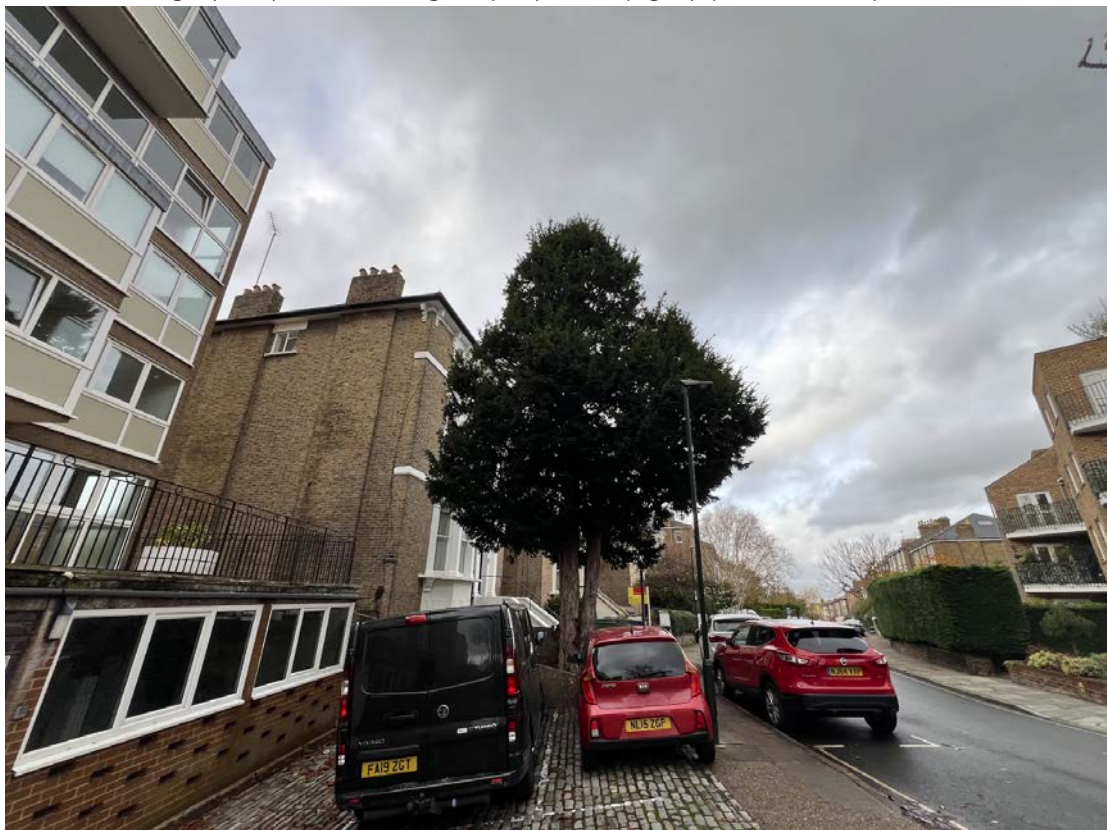
*Photographic plate showing T18 (centre). (ROAVR, 2025)*

| Tree ID | Species | Tree Height | Maturity | DBH | Life Expectancy | Phys Cond | Defects | Defect details | Management Recommendations | Estimated Duration of works | Priority |
|---|---|---|---|---|---|---|---|---|---|---|---|
| T18 | Taxus baccata (Yew) | 10 | M | 450,400 | 20+ | Good | Tree located within hard surface area. Tree located within raised bed. Stem divides at ground level. | None | None | None | None |

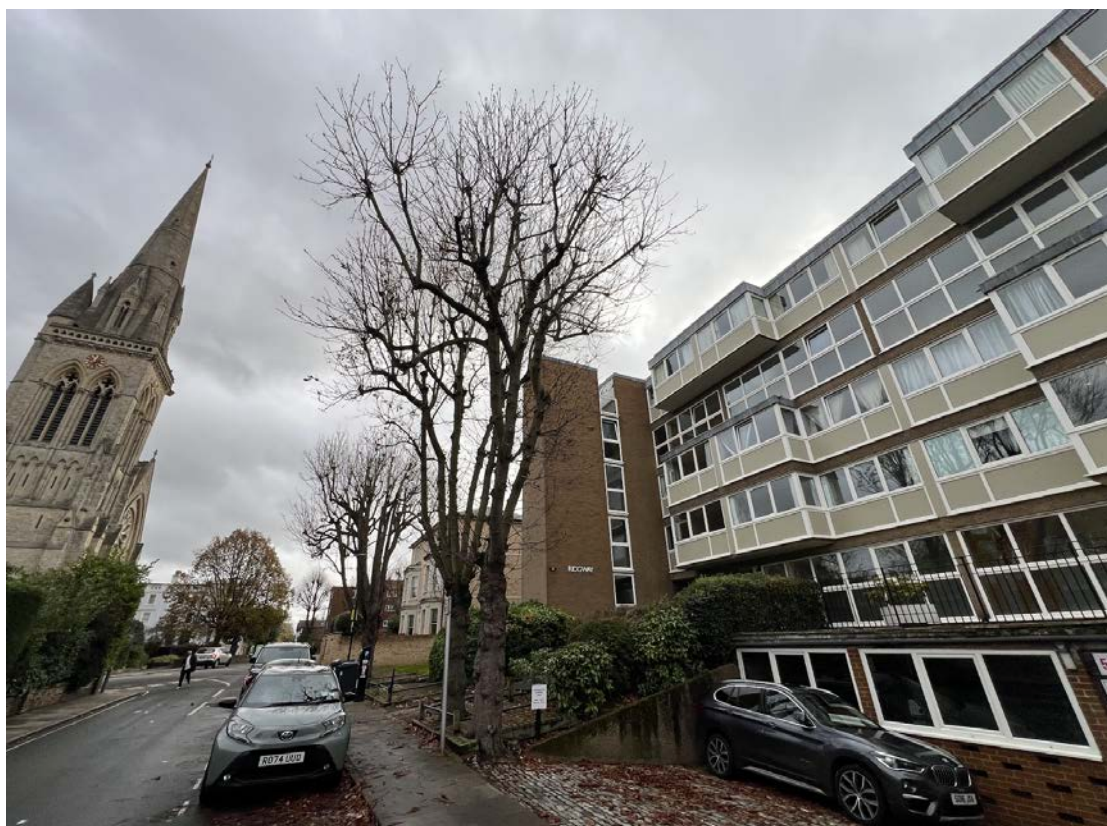
*Photographic plate showing T19 (right) to T22 (left). (ROAVR, 2025)*

- T20 Sycamore has fruiting bodies at the southern base, likely *Coprinellus* spp. associated with dead wood rather than active decay of the stem; the stem sounded solid on mallet testing and no further investigation is required at this stage.

| Tree ID | Species | Tree Height | Maturity | DBH | Life Expectancy | Phys Cond | Defects | Defect details | Management Recommendations | Estimated Duration of works | Priority |
|---|---|---|---|---|---|---|---|---|---|---|---|
| T19 | Aesculus hippocastanum (Horse Chestnut) | 15 | M | 450 | 20+ | Good | Tree located within hard surface area. | Damaging a section of the block paving. | None | None | None |
| T20 | Aesculus hippocastanum (Horse Chestnut) | 15 | M | 450 | 20+ | Good | Tree located within hard surface area. | Damaging a section of the block paving, mushroom fungi around base to the south. | None | None | None |
| T21 | Aesculus hippocastanum (Horse Chestnut) | 15 | M | 650 | 20+ | Good | Tree located within hard surface area. | Damaging a section of the block paving, pruning wounds throughout. | None | None | None |

| T22 | <i>Aesculus<br/>hippocastanum</i><br>(Horse Chestnut) | 15 | M | 650 | 20+ | Good | Tree located within hard<br>surface area. | Damaging a section of the block paving,<br>pruning wounds throughout. | None | None | None | |

Several Horse Chestnuts (T19–T22) are already lifting and damaging block paving around their bases, and further surfacing disturbance is likely as they mature. This will need to be managed through localised repairs, selective root management if appropriate, and careful planning of any future resurfacing.

A Horse Chestnut (T20) with fungal fruiting bodies at the base should be inspected in more detail to identify any decay and confirm that stability remains acceptable. Apart from these points, no immediate high-risk tree defects were recorded during the survey. A three-yearly inspection cycle, with interim checks after severe storms, is recommended so that emerging defects, surfacing issues and building interactions can be identified early and addressed in a planned way.
